**Phase I Environmental Site Assessment
Former North Charleston City Hall
4900 Lacross Road
North Charleston, South Carolina
Charleston County TMS No. 472-00-00-011**

April 13, 2012

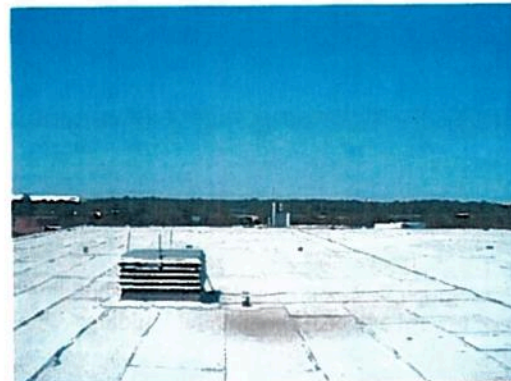
Photograph 4: View of building roof.

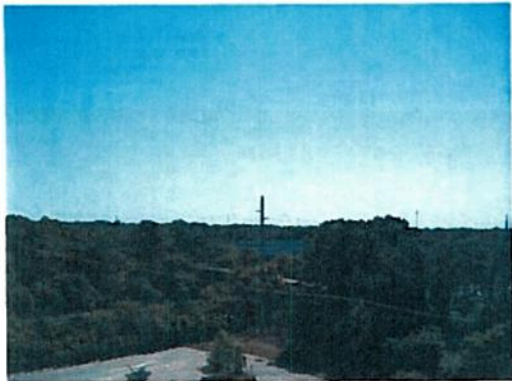
Photograph 7: Looking east from the building roof toward Mall Drive.

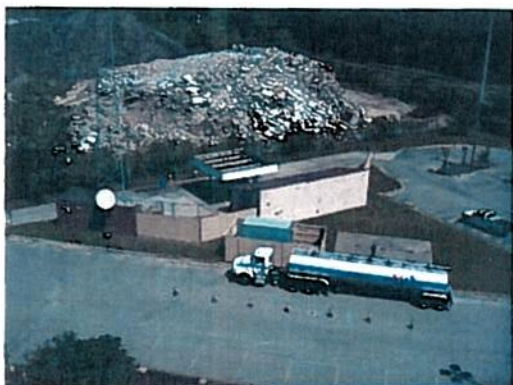
An air conditioning cooling tower is located to the north of the building. Empty and partially full containers of algacide are present around the base of the cooling tower. The northern portion of the property contains a UST system consisting of three 4,000-gallon gasoline USTs and two dispensers. Stains indicative of spills were not observed around the three UST fill ports or the two dispensers. A spill kit was noted in the vicinity of the dispensers. Approximately five flush mounted groundwater monitoring wells were observed to the southeast, east, and northeast of the three USTs.

Photograph 13: Overhead view of the onsite UST system as seen from the building roof.

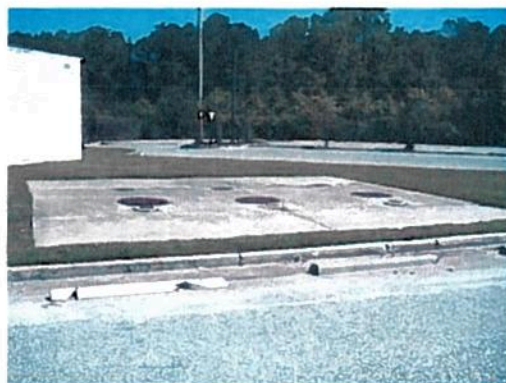
- A fuel dispensing system, consisting of three underground storage tanks (UST), fuel lines, and fuel dispensers was identified on the Property. The Property was identified in the Leaking UST (LUST) database. A release was reported in May 1997 and was subsequently issued a letter of no further assessment/action in September 2006. The release of petroleum and the continued storage and distribution of petroleum on the Property represents a REC.

The Property is the site of the former North Charleston City Hall and is identified in UST, LUST, GWCI and FINDS databases. The City of North Charleston currently operates three 4,000-gallon USTs containing regular unleaded gasoline. A release was reported in May 1997 and NFA letter was issued in September 2006. Groundwater underlying the Property is reported to flow to the east. The Property has qualified for the State Underground Petroleum Emergency Response Bank (SUPERB) program. GEL observed five groundwater monitoring wells on the Property in the vicinity of the USTs. The presence of a petroleum release and the continued operation of USTs on the Property represent an onsite REC.

Photograph 14: View of the three 4,000-gallon gasoline USTs.

- No significant data gaps were noted.
- No additional assessment is recommended for the onsite REC. The petroleum release associated with the onsite UST system has been issued a No Further Action (NFA) letter. Groundwater is documented to flow to the east which will minimize potential impacts to the onsite structure by any residual petroleum hydrocarbons remaining in the vicinity of the UST system. The release is also qualified to receive funding from the State Underground Petroleum Emergency Response Bank (SUPERB).

No additional assessment is recommended for the petroleum release associated with the onsite UST system. The release has been issued a letter of NFA. Groundwater is documented to flow to the east which will minimize potential impacts to the onsite structure by any residual petroleum hydrocarbons remaining in the vicinity of the UST system. The release is also qualified to receive funding from SUPERB.

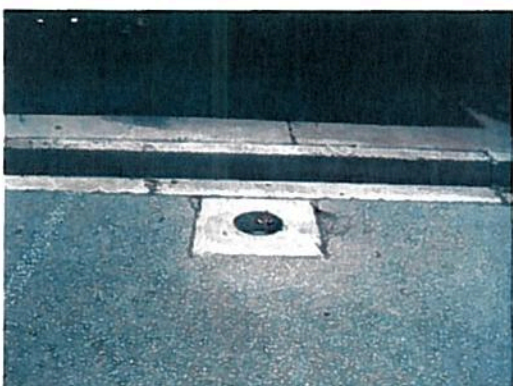
Photograph 14: Typical view of one of five onsite groundwater monitoring wells.

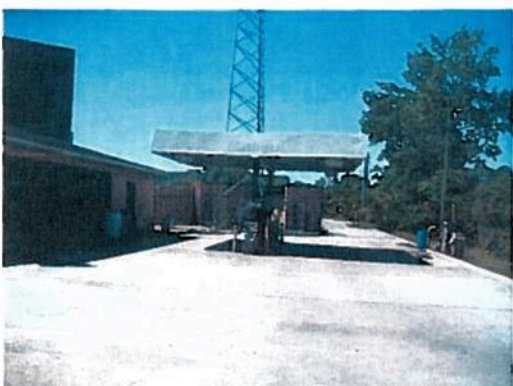
Observations		
Description	Reported/ Observed Onsite (Y/N)	Comments
Hazardous Substances and Petroleum Products in Connection with Identified Uses	Y	An active fuel dispensing system consisting of three 4,000-gallon gasoline USTs and two dispensers is located north of the onsite structure. Five groundwater monitoring wells are located in the paved areas surrounding the UST system. Regulatory records and personnel confirm that a release has been documented, delineated, and closed.
Hazardous Substances and Petroleum Products Containers Not in Connection with Identified Uses	N	None
Storage Tanks	Y	Three 4,000-gallon gasoline USTs and a 1,700-gallon double-walled AST associated with an emergency generator were noted.
Strong, Pungent, or Noxious Odors	N	None
Pools of Liquid	N	None
Drums	Y	Drums containing a spill kit, window washing fluid, etc. were noted in the vehicle fueling area. No obvious staining or odors indicative of releases were observed.

Photograph 14: View of the dispenser island located in the northern portion of the property.

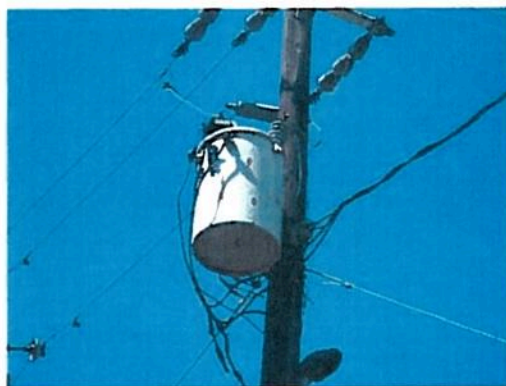
Unidentified Substance Containers	N	Empty and partially full containers of suspected algaecide were noted in the vicinity of the cooling tower located to the north of the onsite structure.
Potential Polychlorinated Biphenyls (PCB)-Containing Equipment	Y	A single pole mounted transformer was observed along the northern property line. A pad mounted transformer is located at the northwestern corner of the building. Neither transformer was marked with a blue label indicating it had been tested and is free of PCBs; however, the transformer was in good condition and no indications of a release were noted.

Photograph 14: View of pole-mounted transformer located along northern property line.

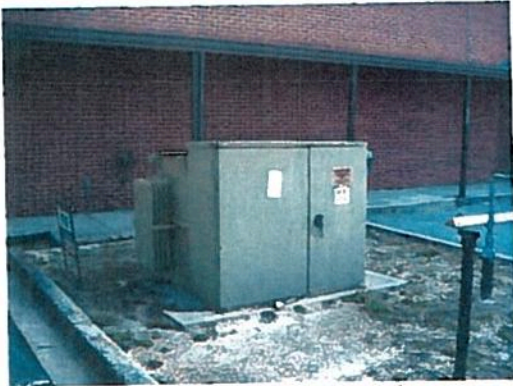
Photograph 13: View of pad mounted transformer located at the northwestern corner of the onsite building.

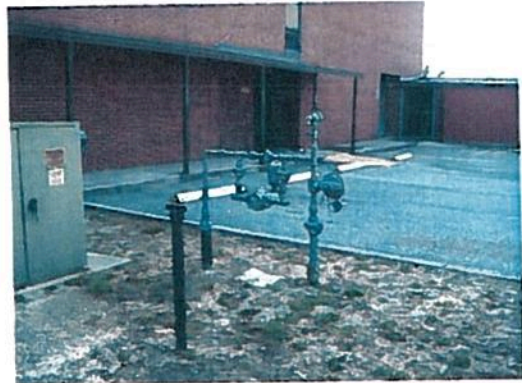
gas leak. The Department was at the Property for approximately five minutes investigating the natural/propane gas leak. The incident does not represent a REC.

Photograph 14: View of natural gas meter located at the northwestern corner of the onsite building.

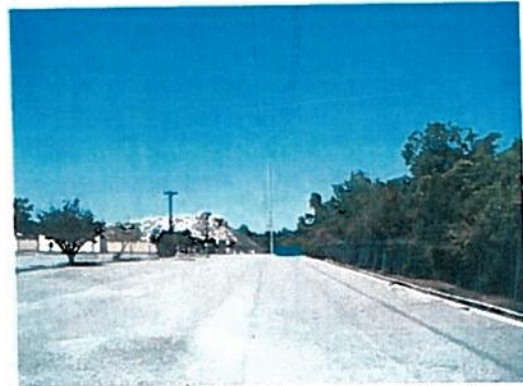
Observations		
Description	Reported/ Observed Onsite (Y/N)	Comments
Hydraulic Equipment	N	None
Contracted Maintenance Services	N	None
Utilities and Stormwater Management	Y	A SCE&G power line easement occupies the eastern portion of the Property. An SCE&G gas meter is located at the northwestern corner of the building. Water and sewer services are provided by the CWS. Stormwater runoff is collected via storm drains and discharged into a stormwater retention pond located on the Property.
Pits, Ponds, Lagoons, and Surface Waters	Y	A stormwater retention pond is located in the southwestern corner of the Property.
Stained Soil or Pavement	N	None
Stressed Vegetation	N	None
Solid Waste	Y	Recycling bins are located in the northern portion of the Property.
Process/industrial Wastewater Discharges	N	None
Wells	Y	Five flush-mounted groundwater monitoring wells associated with the onsite UST system was observed.

Photograph 14: View of power line right of way paralleling the eastern property line.
